Coastal erosion at Chanonry Ness

The aim of this study is to investigate the types of coastal erosion at Chanonry Ness and how they affect the land use. In addition, the management strategies employed in dealing with this erosion were looked at in detail.

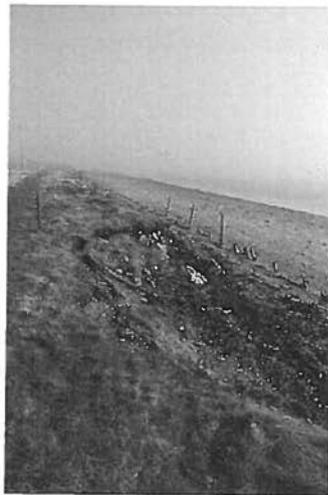
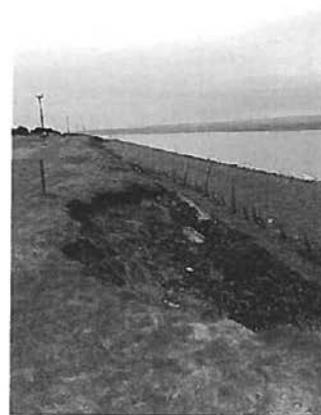
Fig 12.1 (15/02/16)

Site 4 lost 0.26m more land than site 2 in three months. The beach gradient at this site is much steeper than site 2 (Fig 4) so steeper more destructive waves will break against the land. The gradient will also have an effect on underwater elevation. The steeper gradient here will mean that underwater elevation is greater so waves will break closer to shore with maximum erosive power. However, the "maximum erosive power" of waves breaking on this side will be limited by the small fetch area. The main factor contributing towards erosion at site 4 will be the prevailing wind. (Fig 6) Fig 12 illustrates erosion over time at site 4.

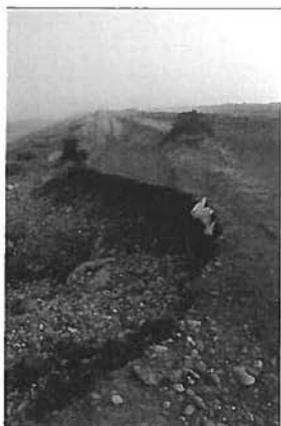
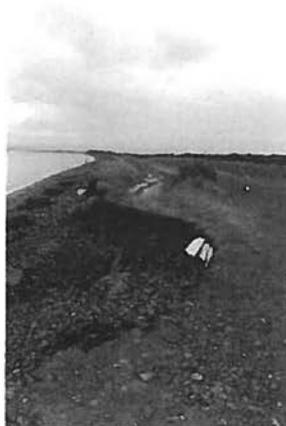
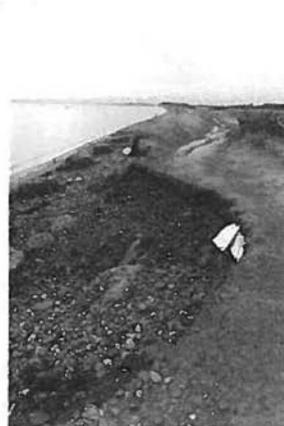
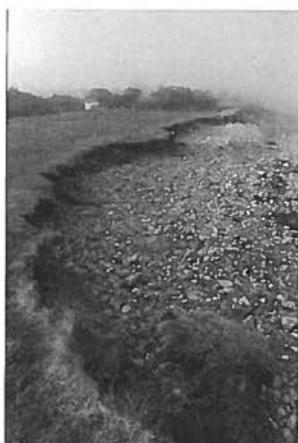
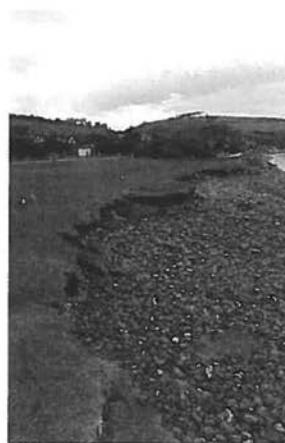
Fig 13.1 (A) (15/02/16)

shingle will be negligible. Figures 13.1 and 13.2 illustrate erosion over time at sites 9 and 11 respectively.

The level of retreat on the East side is fairly similar at the two sites as illustrated by the result for standard deviation. This suggests that coastal erosion is a consistent problem on the East side; more so than on the West side. The East side has a much larger fetch area of around 600km (Fig 6) across the North Sea. The waves will build up more erosive power and will release a huge amount of energy when the break against the land. The waves were observed on the East side as being much more destructive.

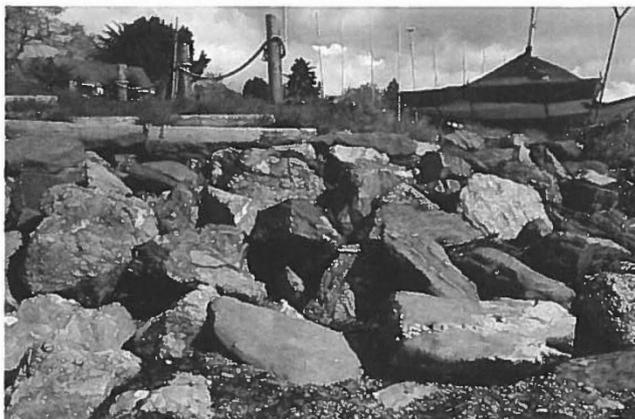
Fig 15 (Fortrose sailing club Boat Park)

If you present a slope of large rocks which interlock; the force of the waves crashing against them will push the rocks downwards and therefore secure the rock slope. A disadvantage to this method is that because it is a slope; on a particularly stormy day, waves will crash over the rocks onto land.

This is a very effective management strategy and has already been employed in Fortrose at the Fortrose sailing club boat park. It was proposed for Rosemarkie caravan site but the Highland Council aren't keen on this method. They would prefer a "softer option". (Pers com) , who works an independent tourism consultant; with expertise in the conservation, recreation and tourism sectors, gave his opinion on what management strategies would be most effective.

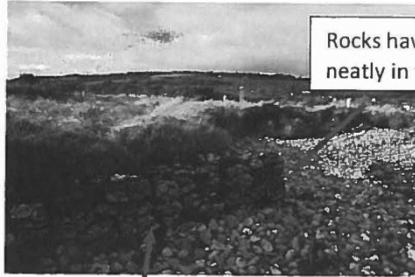
Fig 16.1 Gabions at site 11

Rocks have been arranged neatly in the basket in shelves.

Gabions are at a slight angle to reduce the force of impact from the waves.

Gabions have been employed as a means of erosion protection at areas all around the coast. At the golf course and at one section along the West coast, they have collapsed and the metal baskets have ripped. They are a complete eyesore and are a danger to wildlife and people walking along the beach. They have collapsed due to the rocks just being dumped into the baskets. An effective use of the gabions is at the Rosemarkie caravan site where the rocks have been placed "properly into the baskets."

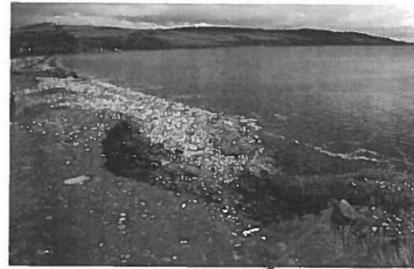
Fig 16.2 Collapsed gabions at site 9

Collapsed gabions have left the soil completely unprotected from the force of the sea. They are also not very attractive.

(Pers com-) At site 9, there is a sewage pipe protruding from the soil due to erosion. This site of erosion is therefore the responsibility of Scottish Water because the sewage pipe is their property. Scottish Water are currently working with the golf club to repair this as soon as possible.
